# Manhole Inspection Summary

Manhole # S71E\_\_012MH

Insp Date: **5/19/08 11:50 AM**

**Location** Address: **Gough St**

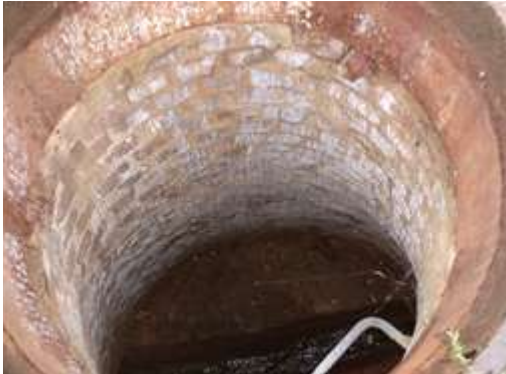
Defect 1

**Frame** Offset: **0** (in.) Condition: ☐ Sound ☐ Cracked ☒ **Leaks**

Frame leaks

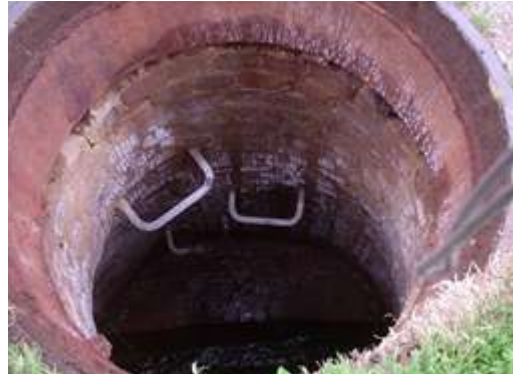
Defect 2

Condition: ☐ Sound ☐ Cracked ☐ Root Intrusion ☒ **Loose Brick** ☐ Deteriorated

Infiltration: ☐ None ☐ Joint ☐ Cracks ☒ **Mortar** ☐ Roots ☐ Wall

Infiltration

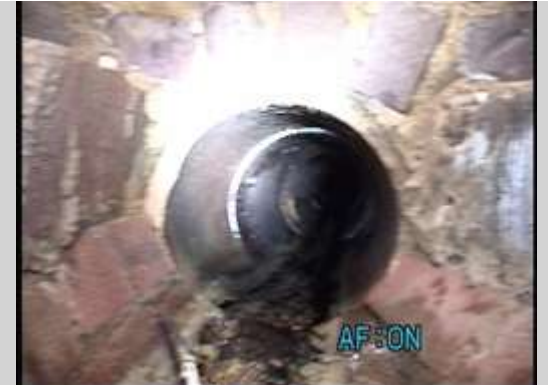
12 O'Clock Outflow

8 in. Circular Gravity Sewer  
Pipe Out @ 12 O'Clock

Pipe Height: **8.4** (in.) Rod and Bar (Angled)  
Pipe Material: **Clay** ☐ Pipe Lined  
Invert Depth: **7.60** (ft.) Flow Characteristics: **Fast**  
Deposits: ☒ None ☐ Mud ☐ Sludge ☐ Debris ☐ Grease  
Silt Depth: (in.) Deposits Extent:  
Infiltration: **None** Pipe Seal Cond: **Sound**

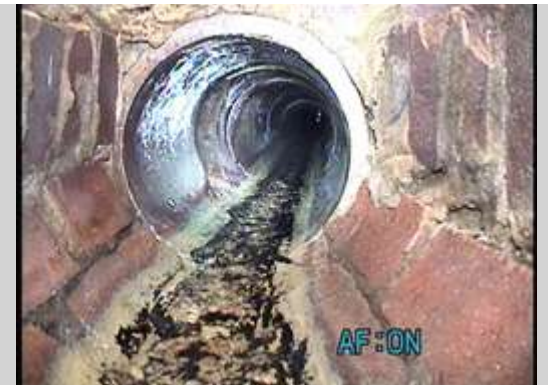
6 O'Clock Inflow

8 in. Circular Gravity Sewer  
Pipe In @ 6 O'Clock

Pipe Height: **8.4** (in.) Rod and Bar (Angled)  
Pipe Material: **Clay** ☐ Pipe Lined  
Invert Depth: **7.55** (ft.) Flow Characteristics: **Fast**  
Deposits: ☒ None ☐ Mud ☐ Sludge ☐ Debris ☐ Grease  
Silt Depth: (in.) Deposits Extent:  
Infiltration: **None** Pipe Seal Cond: **Sound**
